NACA TN 2920

INTERIM REPORT ON A FATIGUE INVESTIGATION OF A  
FULL-SCALE TRANSPORT AIRCRAFT WING STRUCTURE

By M. James McGuigan, Jr.

April 1953

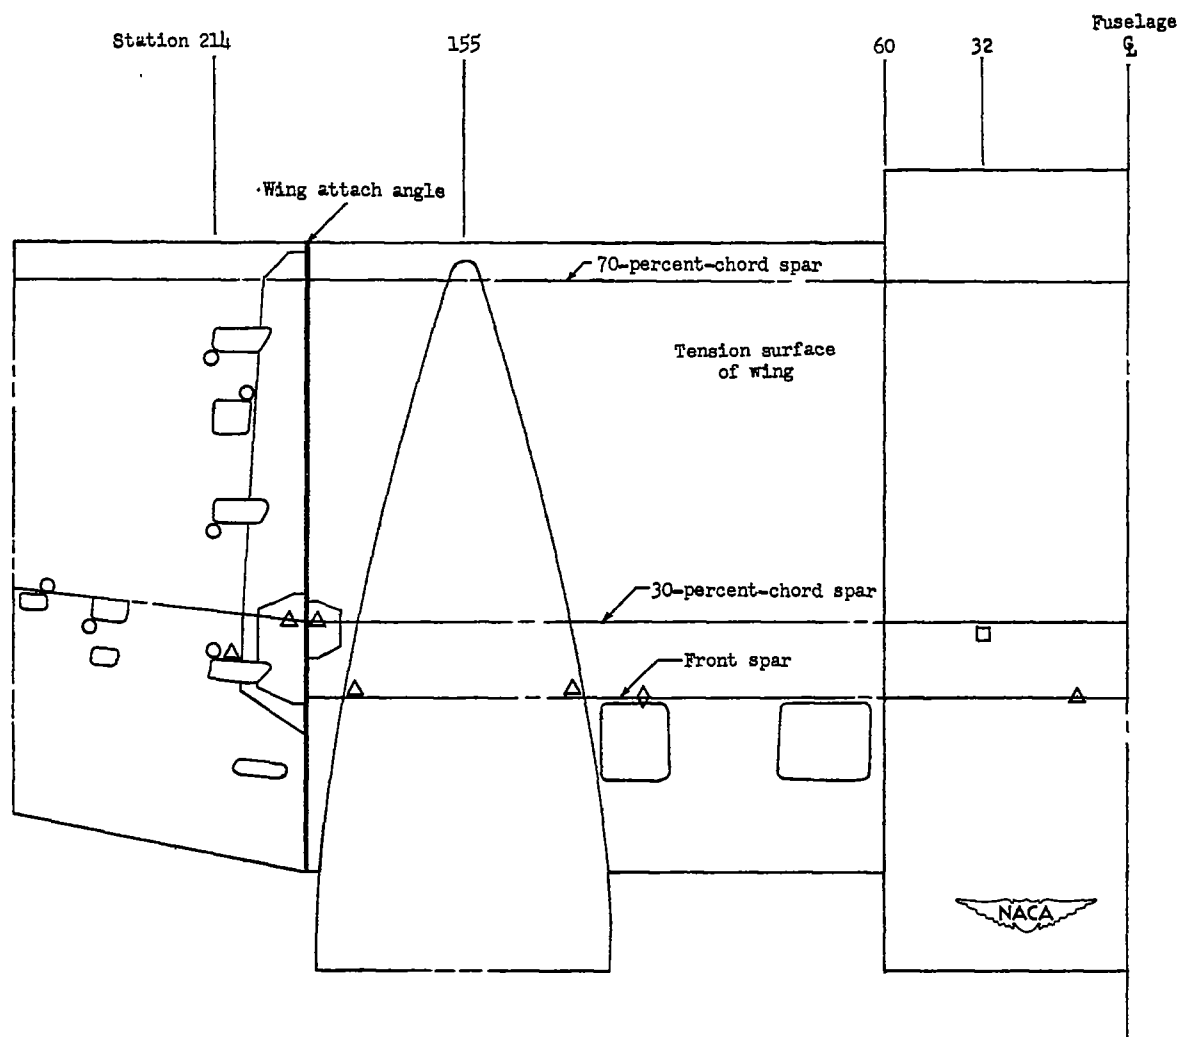
The first type included the 10 failures which originated at the corners of inspection cutouts. The second type included the 6 failures which occurred in a riveted tension joint near the center line of the aircraft. The third type included the 6 failures which occurred in a riveted shear joint where the shear web of the front spar was riveted to the tension flange of that spar. The fourth type included 12 failures which originated at abrupt changes or discontinuities in section or shape, such as the edge of a reinforcing doubler plate. The points of initiation for these four types of failure are shown in figure 7 which is a plan view of the tension surface of the wing. For convenience, failures that occurred on both wings are shown on a portion of one semispan.

Figure 7.- Location and types of fatigue failures.

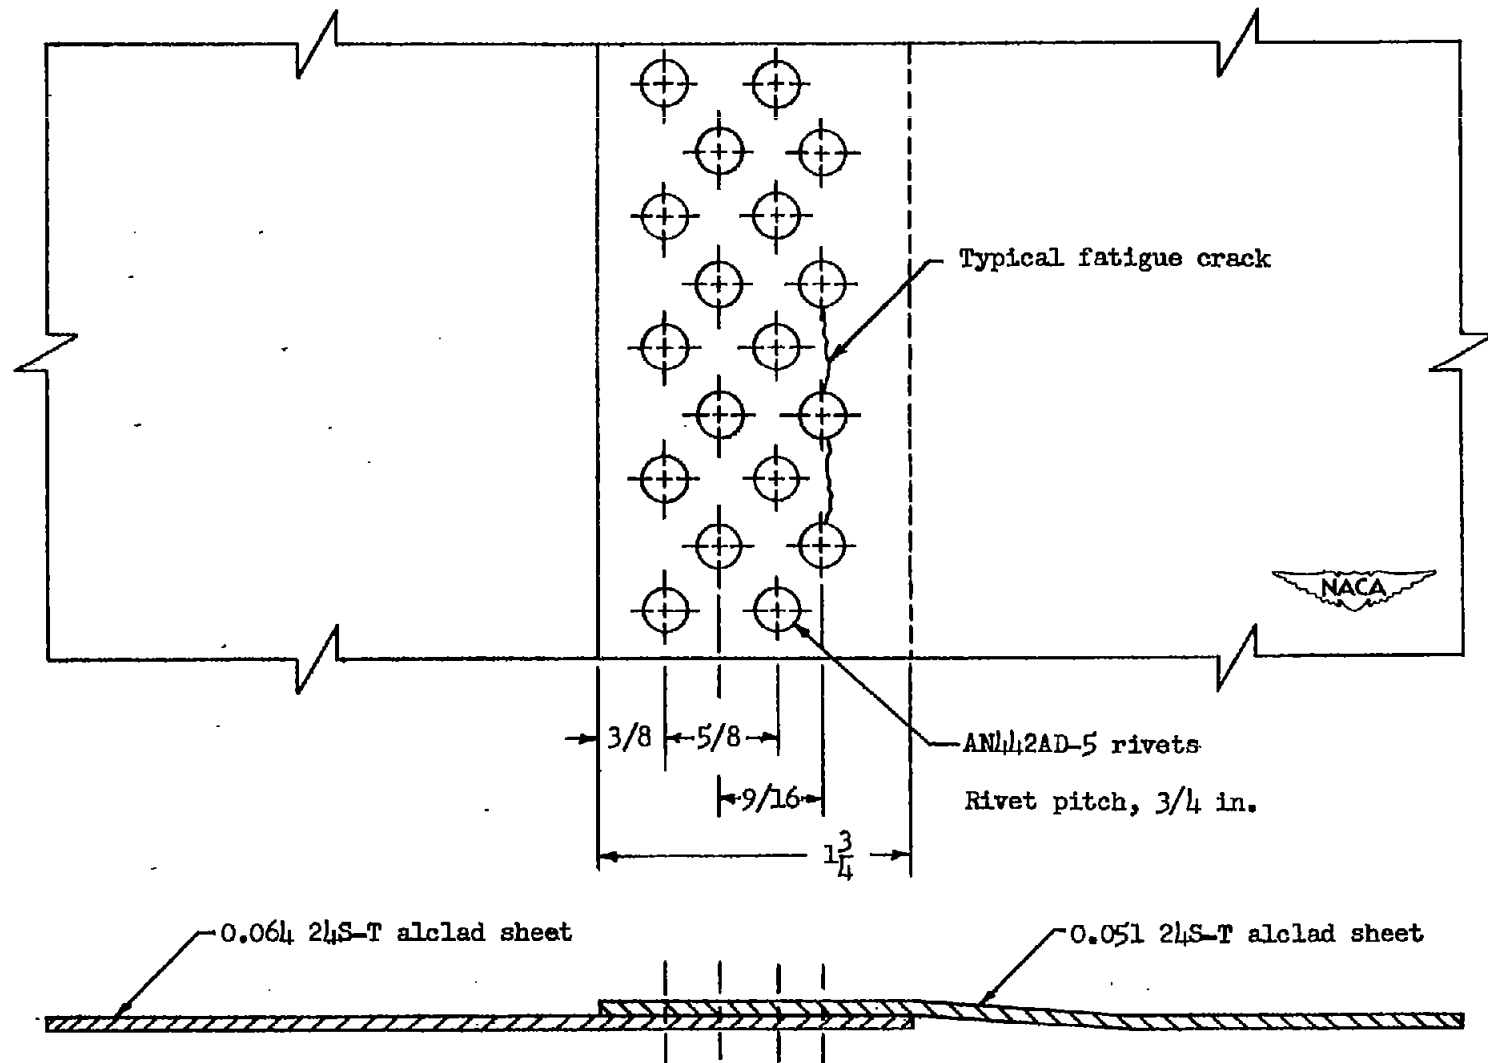
The second type of failure occurred in a riveted tension joint 32 inches from the aircraft center line. The joint extended chordwise at this wing station from the front spar to the rear spar. Failures of this type appeared on the left and right wing of the first three wing center sections in the same chordwise location and are listed as failures 1, 2, 11, 14, 22, and 23. The details of this joint and the manner of failure are shown in figure 12. The measured chordwise stress distribution through this section is shown in figure 13, from which it may be seen that the highest stress occurs at the point where all the failures originated.

Figure 12.- Details of riveted tension joint at span station 32. All dimensions are in inches.

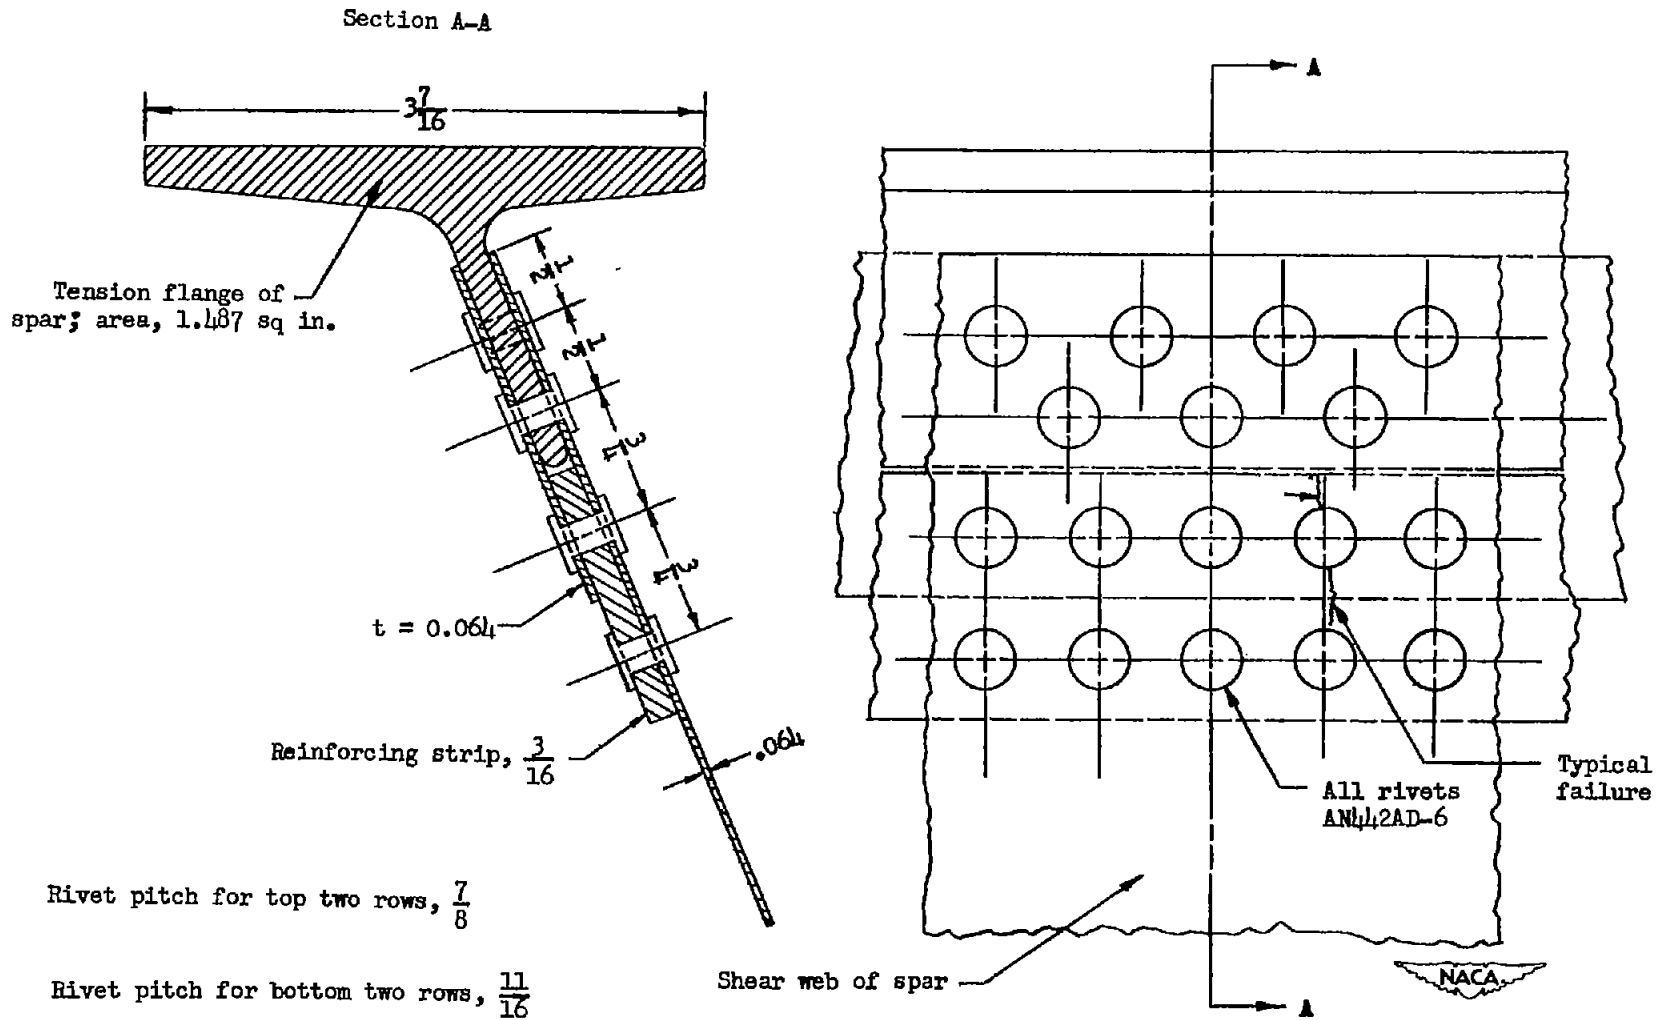
The third type of failure occurred in a riveted shear joint at span station 120 where the shear web of the front spar was riveted to the tension flange of that spar. There were four horizontal rows of rivets in the shear web and the fatigue failures originated in a rivet in the third row away from the tension surface of the wing as can be seen in figure 14. These failures are numbered 8, 9, 20, 21, 28, and 32. Although this joint is designed primarily for shear, strain-gage rosette measurements near the point of failure showed the principal stress to be approximately parallel to the tension flange of the spar. This condition would indicate that the failures were probably primarily due to tension stresses. The shear at this point in the spar was probably small since the spar ends a short distance outboard of this point as can be seen in figure 7.

Figure 14.- Details of riveted shear joint at span station 120. All dimensions are in inches.

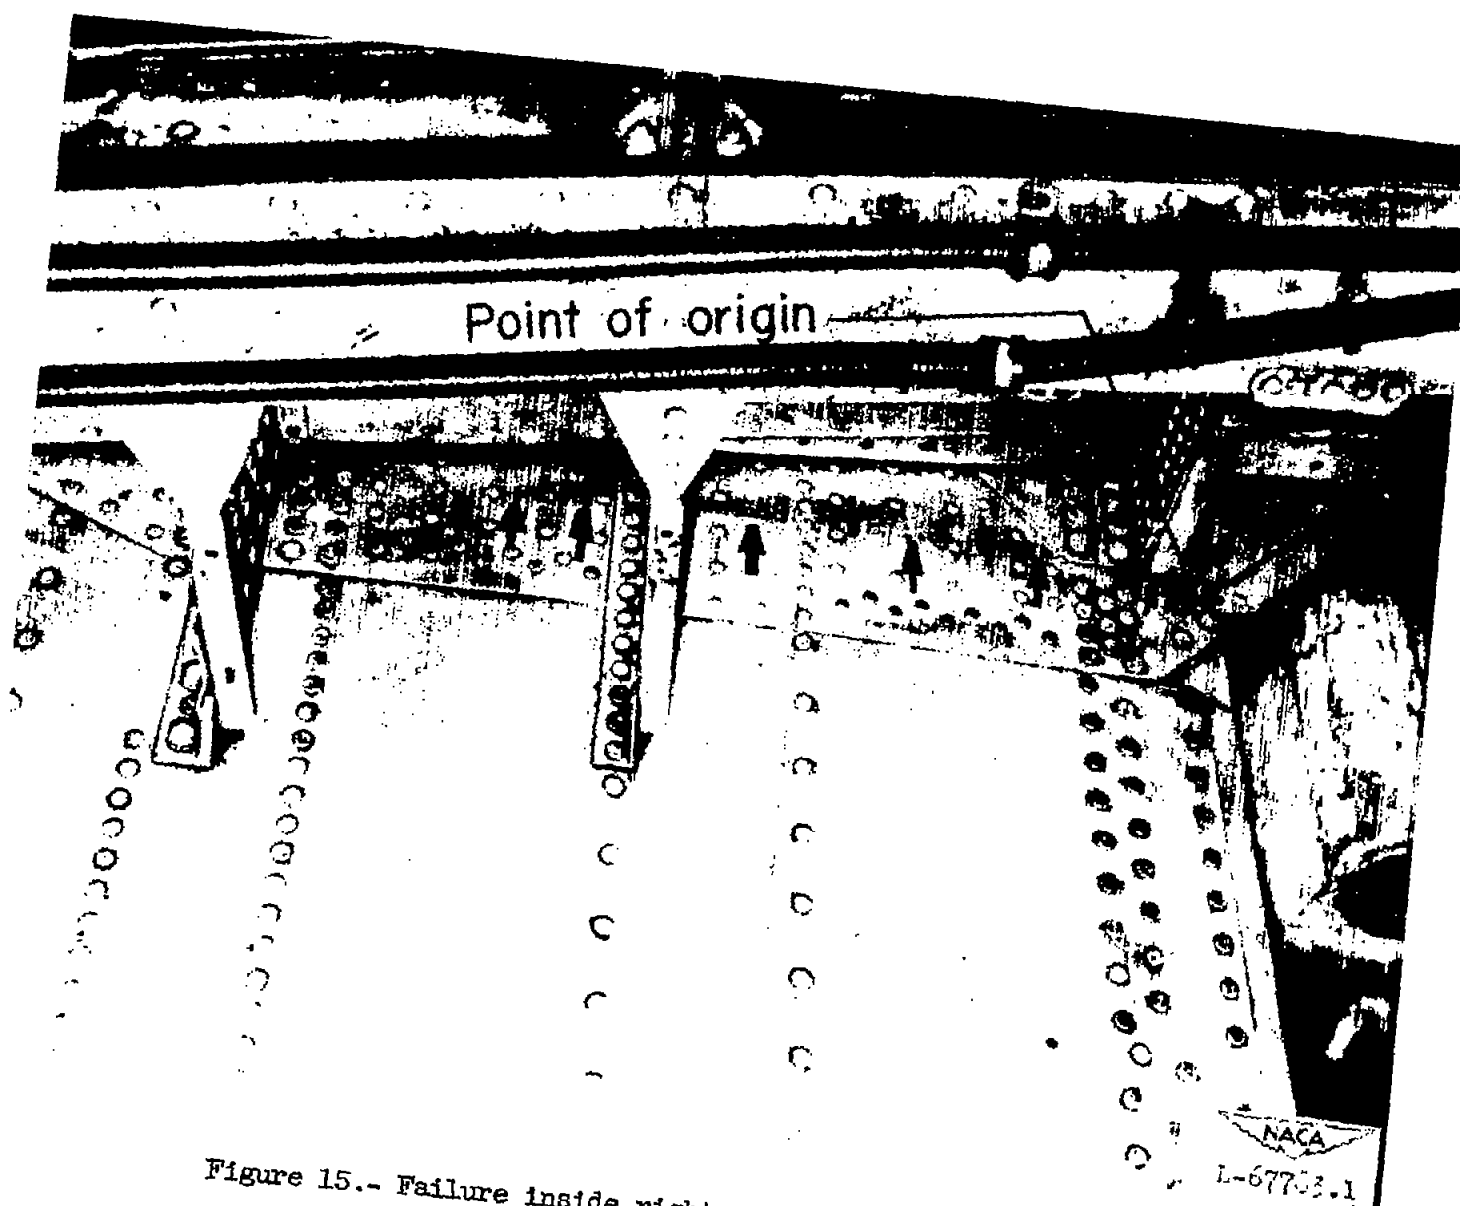
A typical example of those cracks which occurred at the junction of the engine nacelle and the wing spar and which are grouped in the fourth type is shown in figure 15. The failure shown is similar to failures 6, 7, 18, 19, and 30 and originated in a rivet hole near a half-round notch cut in the edge of the skin to eliminate interference of the landing-gear retracting strut with the wing skin during operation of the landing gear. Another failure of the fourth type which was repeated often occurred in a chordwise joggle in an external doubler plate near the wing attach angle. These failures appeared in three left wings and one right and are numbered 4, 10, 16, and 29. Failures were expected to occur at this point since the brittle-lacquer static test had indicated a high stress in this region. An example of this failure is shown in figure 16 after it had progressed to a considerable length.

Figure 15.- Failure inside right nacelle, span station 170.
